S-281  
William J. Coulbourn Farm  
Hopewell vicinity  
private

# Maryland Historical Trust State Historic Sites Inventory Form

Survey No. S-281

historic William J. Coulbourn Farm

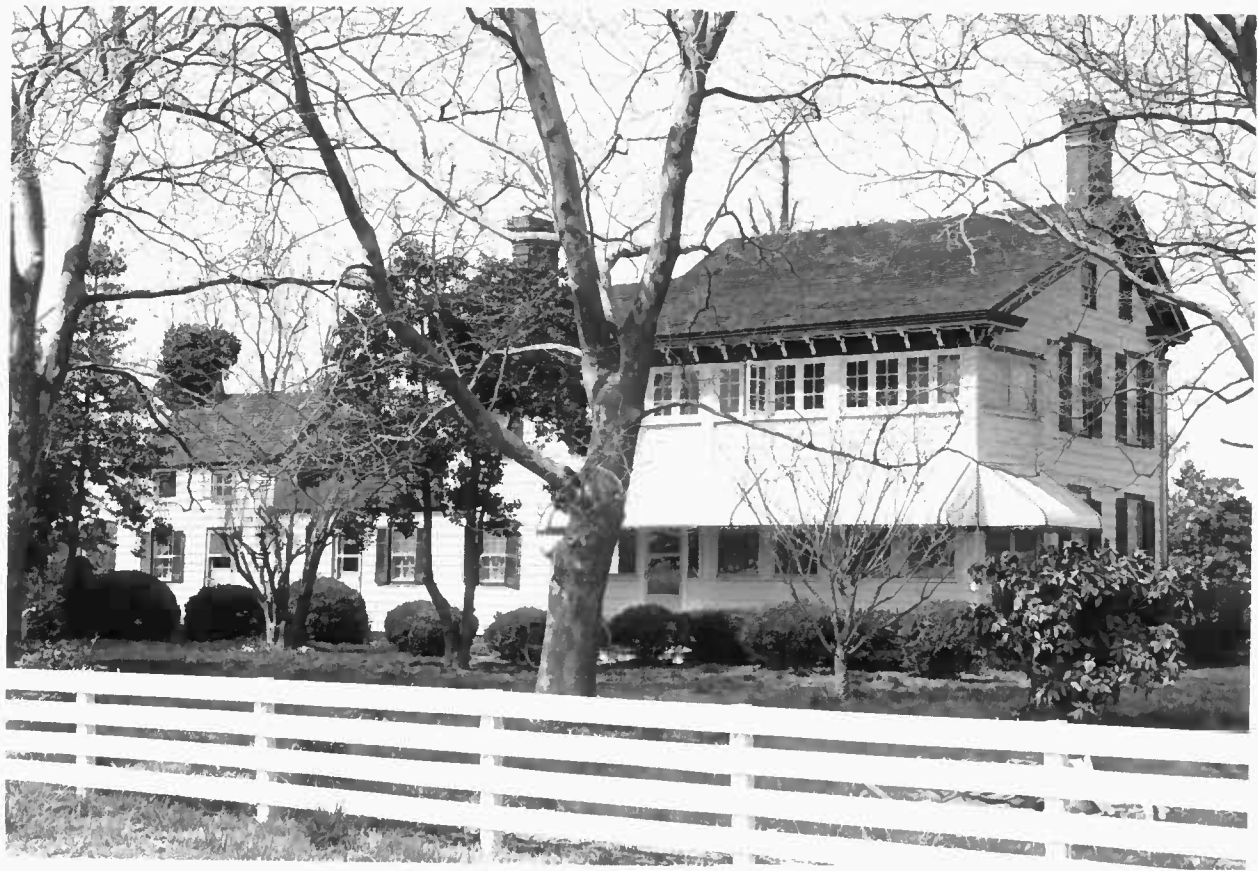
S-281

The east elevation is a nine-bay facade divided into four parts. The main block is three bays across, and it is covered by an enclosed two-story porch. The porch roof is a continuation of the main roof slope; the corners are marked with paneled pilasters, and the eaves are bracketed. The front wall of the house, now enclosed behind the porch wall, has an entrance in the south (left) bay. The paneled front door is topped by a criss-crossed muntin transom. Six over six sash windows fill the adjacent two bays. The second floor is divided into three bays with a second floor porch door in the south bay and two six over six sash to the north.

Near Marion, Somerset County  
East Elevation

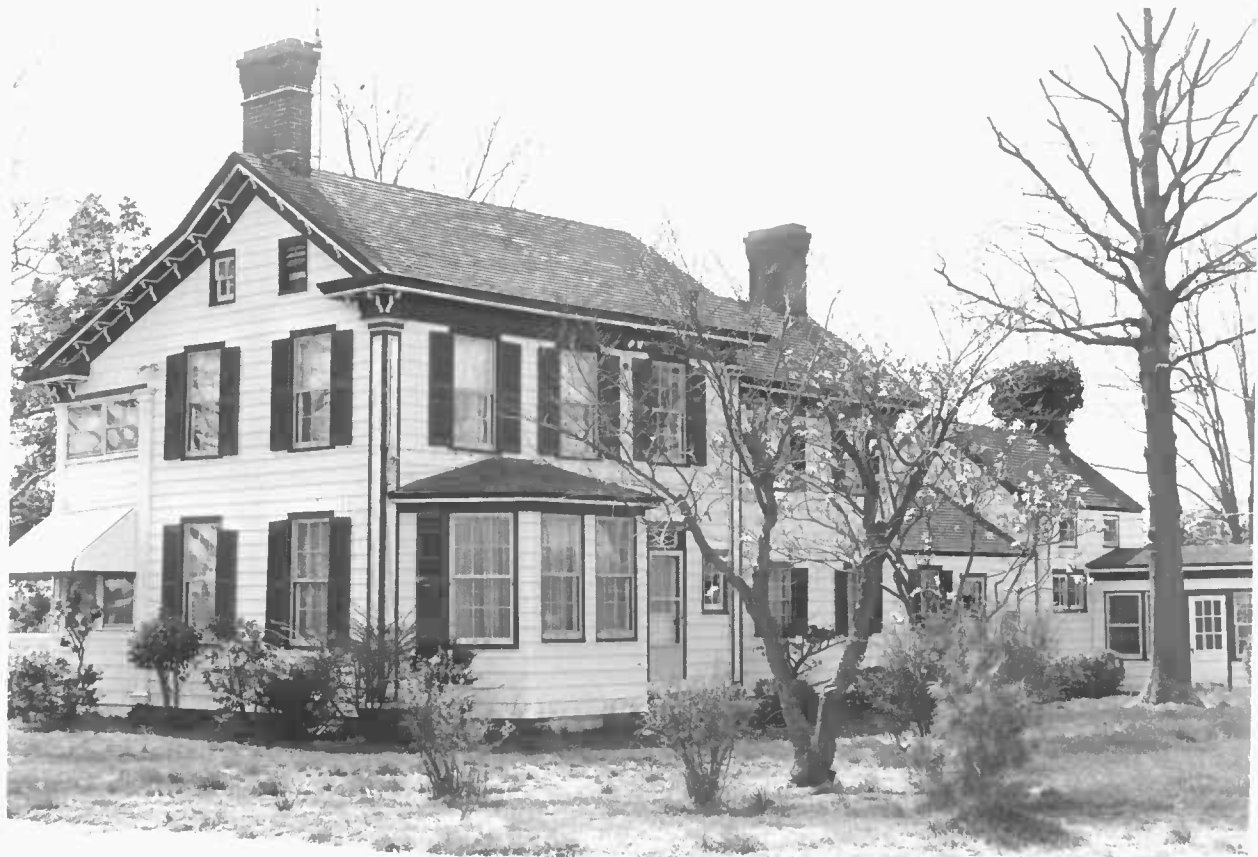
S-281

The north gable end of the main house is a symmetrical elevation with six over six sash on each floor flanked by louvered shutters. A pair of 2/2 attic sash flank the interior end brick chimney, which is finished with a corbelled cap.

The west (rear elevation has a three-sided bay window that lights the first floor with six over six sash windows. A back entrance to the hall has a partially glazed door and a criss-crossed muntin transom. A side six-pane window lights a small bathroom below the stair. The second floor is evenly divided into three bays with six over six sash windows and louvered shutters.

Northwest Elevation
